Testing of Fiber Composite Reinforcement Utility Products

Pole Life Systems, Inc.

January 17, 2018

POLE LIFE SYSTEMS PRODUCT TESTING TO ANSI 05.1-2015

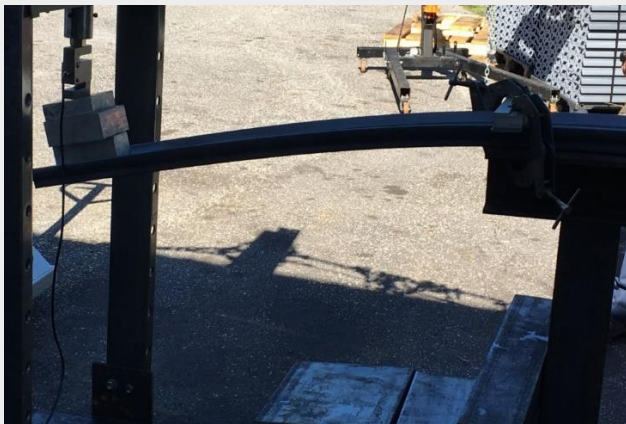
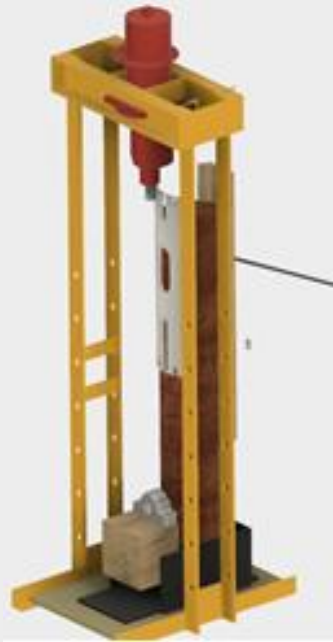
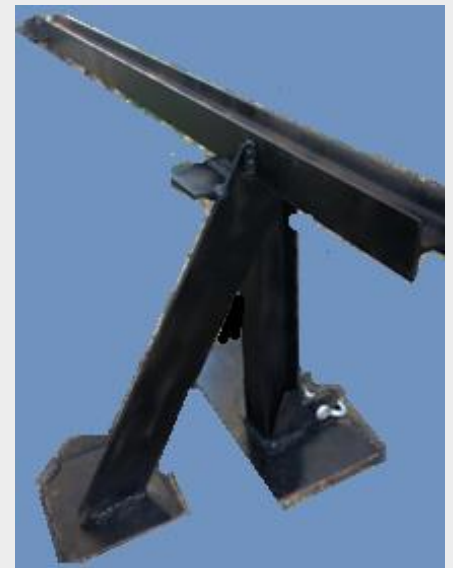
- i. Not shown, are the various clamping devices, such as C-Clamps, Bolts, and Chains.
- ii. Drawings in Views are mainly used for demonstrations and don't always reflect true parts.
- iii. Illustrated below are a representation of the major test equipment and fixturing used:

Cantilever and Compression Methods – Applied

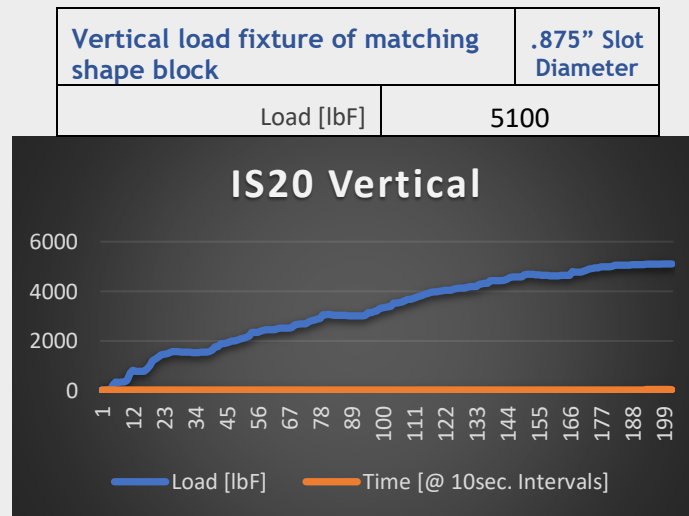
Figure 2.10.4 – Arrow indicated area image no-break

IS20 Vertical part - applied force to 5100 [lbf] in noted area as shown in Figure 2.10.4

*Notable: No cracks were observed in base composite material. Indenture from force noted with 2 slight laminate cracks.

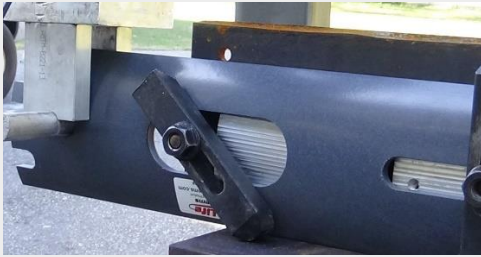
Figure 2.11.3 – Actual load test image

This testing was conducted utilizing locked down fixtures as shown in Fig. 2.11.3 and force was applied by a 20 ton Hydraulic Ram with a Mark-10 MR01-5000 Force Sensor Load Cell mounted to fixture load head, with Computer Data output capture software as charted.

IS20 Longitudinal part - cracked at 1200 [lbf] in marked areas as shown in Figure 2.11.4 Load applied, as in Fig. 2.11.3 until distinct cracks sounded and verified by observation.

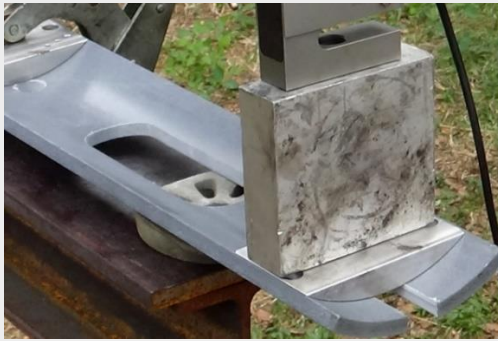
Figure 2.12.3 – Actual load test image

This testing was conducted utilizing locked down fixtures as shown in Fig. 2.12.3 and force was applied by a 20 ton Hydraulic Ram with a Mark-10 MR01-5000 Force Sensor Load Cell mounted to fixture load head, with Computer Data output capture software as charted.

IS20 Transverse Inside part - cracked at 1800 [lbF] in marked areas as shown in Figure 2.12.4 Load applied, as in Fig. 2.12.3 until distinct cracks sounded and verified by observation.

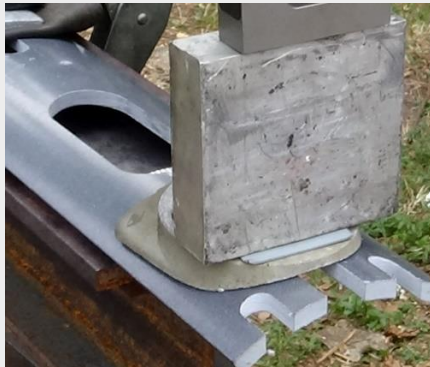
Figure 2.13.3 – Actual load test image

This testing was conducted utilizing locked down fixtures as shown in Fig. 2.13.3 and force was applied by a 20 ton Hydraulic Ram with a Mark-10 MR01-5000 Force Sensor Load Cell mounted to fixture load head, with Computer Data output capture software as charted.

IS20 Transverse Outside part - cracked at 1350 [lbF] in circled area as shown in Figure 2.13.4 Load applied, as in Fig. 2.13.3 until distinct crack sound was heard and verified by sight.

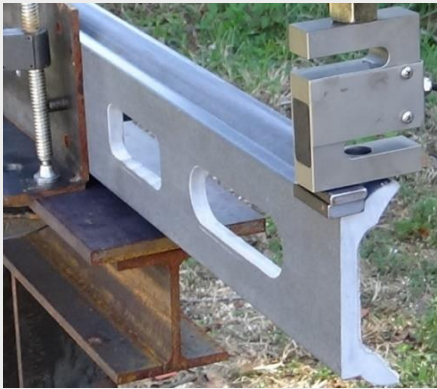
Figure 3.11.3 – Actual load test image

This testing was conducted utilizing locked down fixtures as shown in Fig. 3.11.3 and force was applied by a 20 ton Hydraulic Ram with a Mark-10 MR01-5000 Force Sensor Load Cell mounted to fixture load head, with Computer Data output capture software as charted.

Load applied, as in Fig. 3.11.3 until distinct cracks sounded and verified by observation.

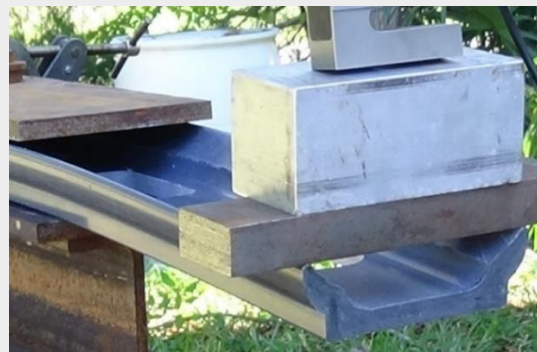
Figure 3.12.3 – Actual load test image

This testing was conducted utilizing locked down fixtures as shown in Fig. 3.12.3 and force was applied by a 20 ton Hydraulic Ram with a Mark-10 MR01-5000 Force Sensor Load Cell mounted to fixture load head, with Computer Data output capture software as charted.

VR30 Transverse Inside part – Load applied to 1500 [lbF] , as in Fig. 3.12.3 distinct crack sounded and verified by observation. *Pic not available.

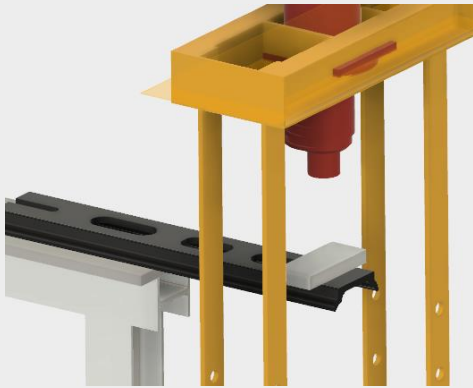
Figure 3.13.1 – Isometric View VR30 Part, anchor, and force Block

This testing was conducted utilizing locked down fixtures as shown in Fig. 3.13.3 and force was applied by a 20 ton Hydraulic Ram with a Mark-10 MR01-5000 Force Sensor Load Cell mounted to fixture load head, with Computer Data output capture software as charted.

VR30 Transverse outside part – Load applied to 1500 [lbF] , as in Fig. 3.13.3 distinct crack sounded and verified by observation. *Pic not available.

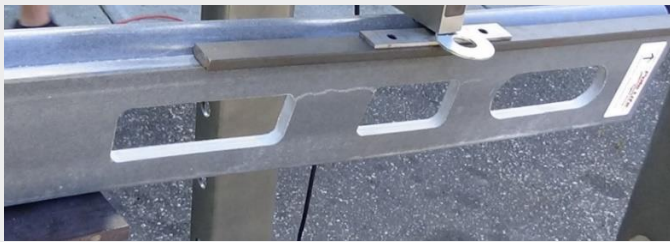
Figure 4.10.3 – Actual load test image

This testing was conducted utilizing locked down fixtures as shown in Fig. 4.10.3 and force was applied by a 20 ton Hydraulic Ram with a Mark-10 MR01-5000 Force Sensor Load Cell mounted to fixture load head, with Computer Data output capture software as charted.

VR48 Longitudinal part – cracked at 1900 [lbF] in marked areas as shown in Figure 4.10.4 Load applied, as in Fig. 4.10.3 until distinct cracks sounded and verified by observation.

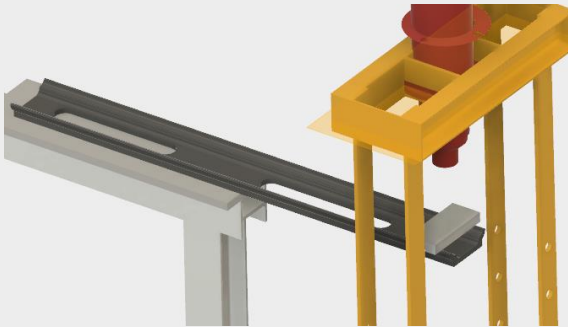
Figure 4.11.1 – Isometric Illustration VR48 Part

This testing was conducted utilizing locked down fixtures as shown in Fig. 4.11.3 and force was applied by a 20 ton Hydraulic Ram with a Mark-10 MR01-5000 Force Sensor Load Cell mounted to fixture load head, with Computer Data output capture software as charted.

VR48 Transverse Inside part – Pressure line in marked areas as shown in Figure 4.11.4
Load applied, as in Fig. 4.11.3 to 1785 [lbf].

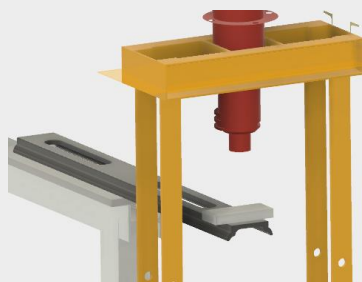
Figure 4.12.1– Isometric Illustration VR48 Part, anchor, and force Block

This testing was conducted utilizing locked down fixtures as shown in Fig. 4.12.3 and force was applied by a 20 ton Hydraulic Ram with a Mark-10 MR01-5000 Force Sensor Load Cell mounted to fixture load head, with Computer Data output capture software as charted.

VR48 Transverse Outside part - cracked at 1680 [lbF] in marked areas as shown in Figure 4.12.4

Load applied, as in Fig. 4.12.3 until distinct crack sound was heard and verified by sight.
